Manhole Inspection Summary

Manhole # S53O__045MH

Insp Date: **3/3/09 11:39 AM**

Location Address: **rear 1300 s ellwood av**

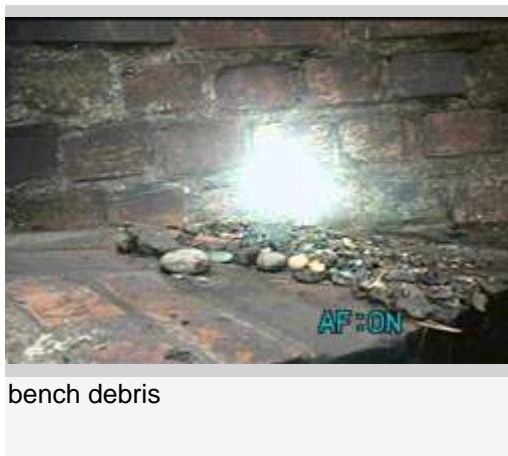
Miscellaneous

bench debris

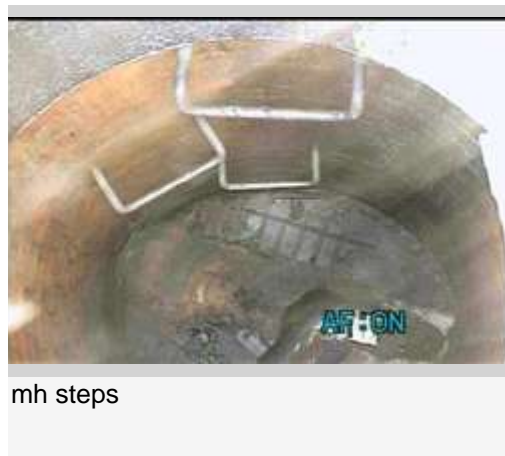
Miscellaneous

mh steps

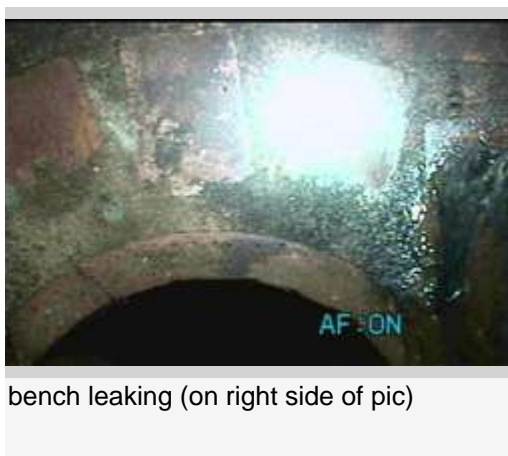
Defect 1

Condition: ☐ Sound ☐ Cracked ☐ Root Intrusion ☐ Deteriorated ☒ Leaks ☐ Debris

bench leaking (on right side of pic)

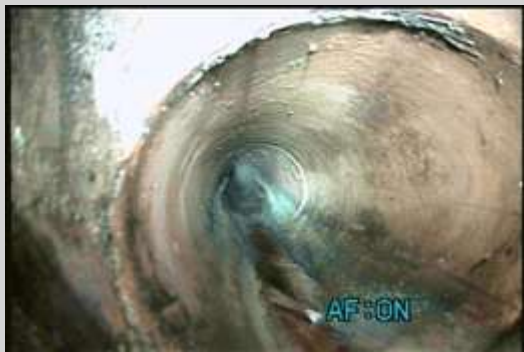
12 O'Clock Outflow

8 in. Circular Gravity Sewer
Pipe Out @ 12 O'Clock

Pipe Material: **Clay** ☐ Pipe Lined

Invert Depth: 7.21 (ft.) Flow Characteristics: **Slow**

Infiltration: **None** Pipe Seal Cond: **Unknown**

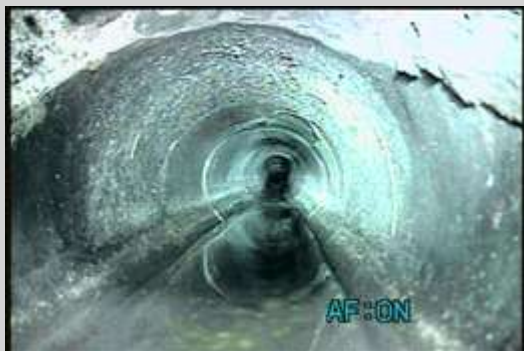
9 O'Clock Inflow

8 in. Circular Gravity Sewer
Pipe In @ 9 O'Clock

Pipe Material: **Clay** ☐ Pipe Lined

Invert Depth: 6.83 (ft.) Flow Characteristics: **Slow**

Infiltration: **None** Pipe Seal Cond: **Unknown**
